Home Inspection Report

1212 Nowhere Street, Yourtown, USA 00000

Pasqua Building Inspections, Inc
6341 Raleigh Street, Hollywood, FL, 33024
www.pasquainspections.com
(954) 981-2365

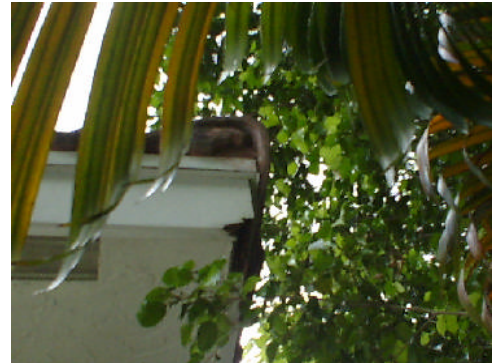
The wood fascia is deteriorated in area(s) as indicated with "F" on the roof diagram.(refer to Wood Destroying Organisms Report)Repair or replace the affected areas.

Photo # 2 DETERIORATED FASCIA

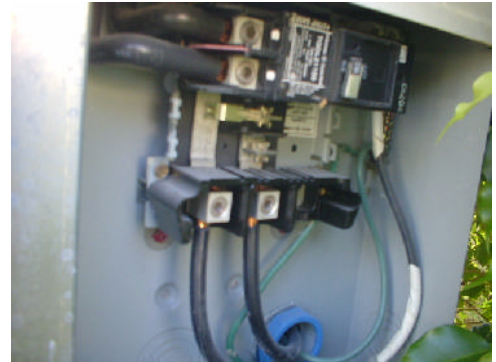
1. There were double tapped breakers present in the main panel. Have the circuits separated by a licensed electrician, and allow for corrections as needed.
2. A globe for an exterior light was broken or missing at the exterior. Allow for repairs or replacements as needed.
3. The master bedroom ceiling fan is not grounded. Ground the fan for safety reasons.

Photo # 3 VIEW OF MAIN PANEL

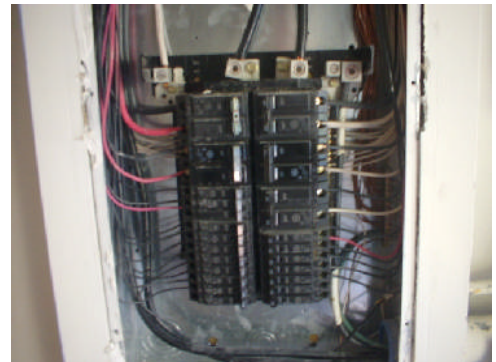
Photo # 4 VIEW OF SUB PANEL

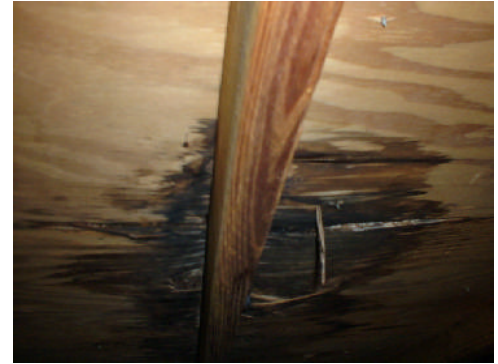
The roof is leaking in area(s) as indicated with "*" on the roof diagram. Recommend repairs by a licensed roofing contractor.

Photo # 5 ROOF LEAK AS OBSERVED FROM ATTIC

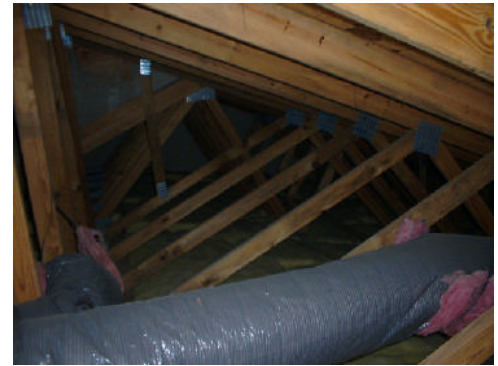
Photo # 6 ATTIC WAS ENTERED
